Property Inspection Report

54 Smart Street

Abbotsville

INSPECTION OF 54 Smart Street Abbotsville

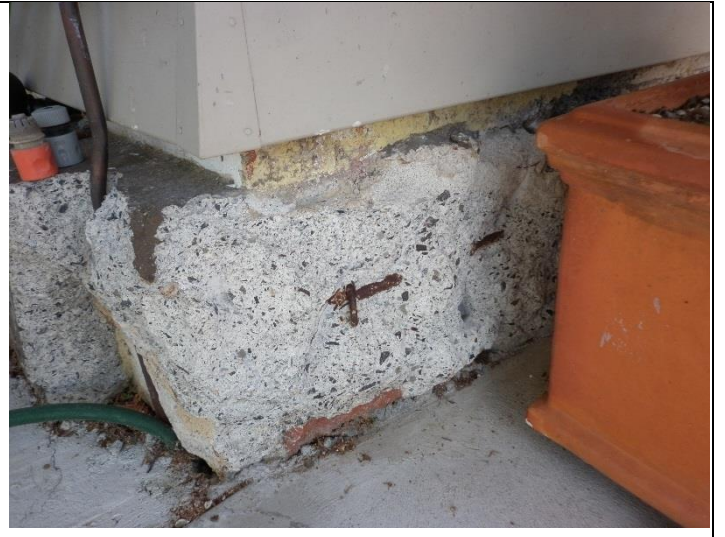
AREA	ITEM	A	B	C	D	R	UR	COMMENTS
SUBFLOOR	Ground Condition		✓					Dry underfloor.
	Ventilation		✓					Vents as required.
	Piles		✓					Concrete piles.
	Joists		✓					Rimu joists to older part of house. Pine joists to alteration.
	Foundation Walls		✓					Concrete filled block walls to garage basement.
	Insulation					✓		Third bedroom has underfloor insulation only.
	Footings						✓	Exposed reinforcing in footing needs plastering.

Exposed reinforcing in footing .Suggested plastering over footing to make good and keep steel from further rust.

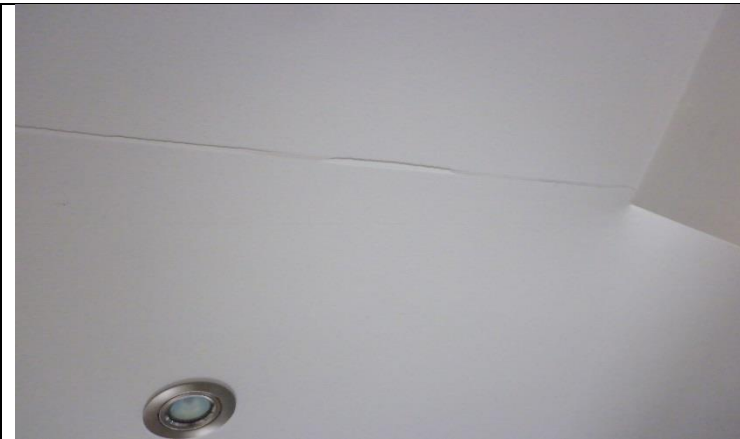
AREA	ITEM	A	B	C	D	R	UR	COMMENTS
HALL WAY	Doors		✓					
	Walls			✓				Paintwork in hallway has been damaged on left hand side.
	Ceiling				✓			Cracks in the hall ceiling need attention.
	Floor Coverings		✓					
	Cupboard Doors		✓					
	Windows		✓					
<p>Comments: Paintwork damage. Cracking in hall ceiling is possibly due to the long expanse of ceiling without any construction joints .This can be rectified by creating one where the crack has appeared.</p>

Crack in hall ceiling possibly due to it being a long hallway with no construction joint in the plasterboard. Suggest putting a construction joint in to stop future cracking.

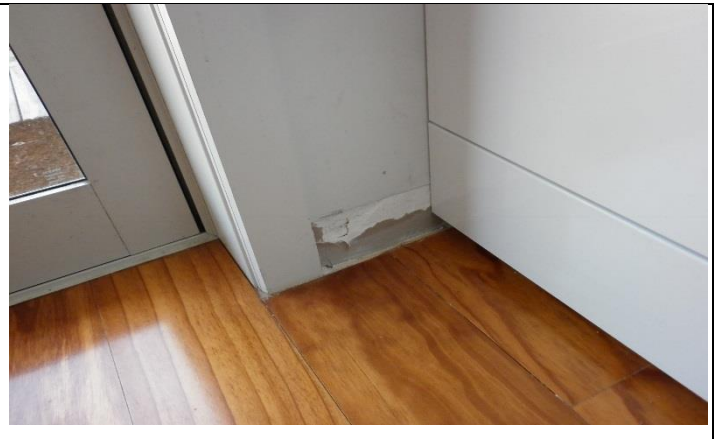
AREA	ITEM	A	B	C	D	R	UR	COMMENTS
LAUNDRY	Doors		✓					
	Walls					✓		Skirting board missing beside tub.
	Ceiling			✓				
	Tub	✓						
	Tapware	✓						
	Floor		✓					
Comments:

Skirting board missing in laundry.

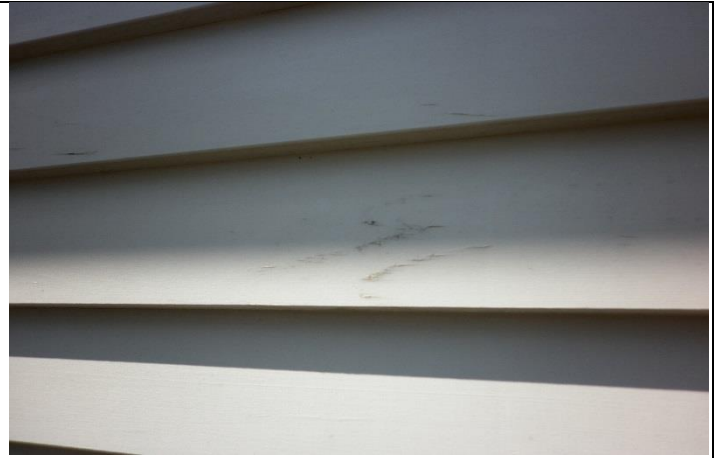
Paint work in need of attention in several areas.

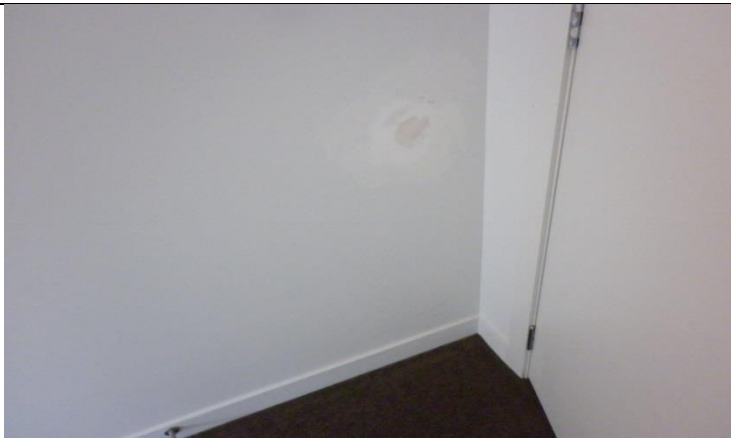
Hole in the wall behind door in third bedroom need finishing.

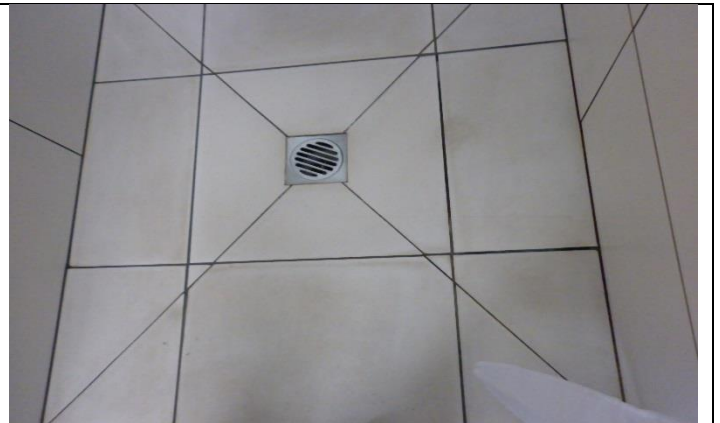
AREA	ITEM	A	B	C	D	R	UR	COMMENTS
ENSUITE BATHROOM	Doors		✓					
	Walls		✓					
	Ceiling		✓					
	Floor Coverings				✓			Grout needs replacing in some tile joints.
	Windows		✓					
	Vanity			✓				
	Shower					✓		Grout needs replacing in some tile joint.
	Toilet		✓					
	Bath							N/A
Comments: Silicon around shower floor need attention.

Ensuite tiles require grout to be redone and silicon around the base also needs to be replaced.
